# Manhole Inspection Summary

Manhole # S35S1\_002MH

**Location** Address: **3300 Potee St. (in the woods)** Cross Street: **Frankfurt Ave.**

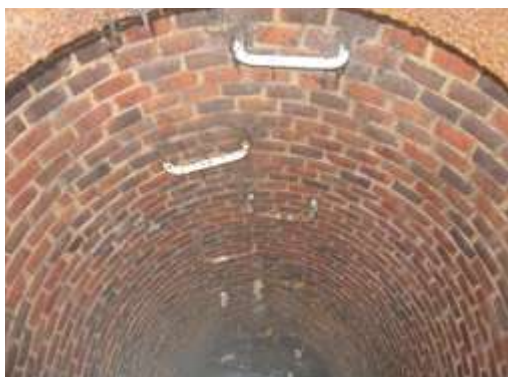
Steps

**Steps** Count: **9** Missing: **0** ☒ **Corroded**

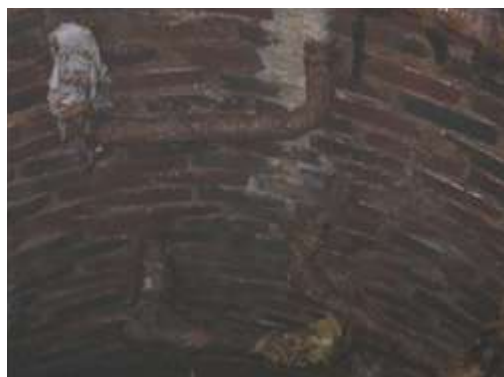
Defect 2

Trash on steps

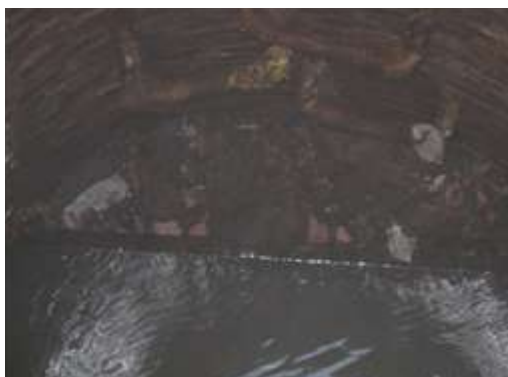
Defect 1

Debris on bench

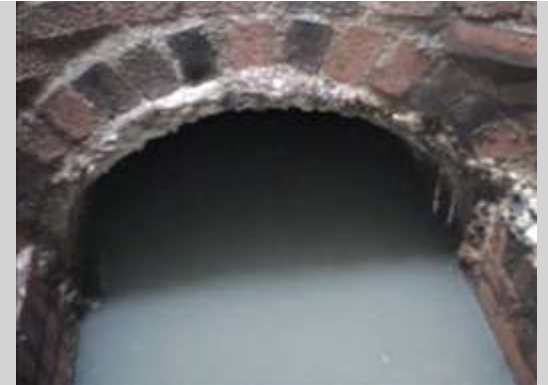
12 O'Clock Outflow

30 in. Circular Gravity Sewer  
Pipe Out @ 12 O'Clock

Pipe Height: **30** (in.) Rod and Bar (Angled)  
Pipe Material: **Concrete** ☐ Pipe Lined  
Invert Depth: **16.38** (ft.) Flow Characteristics: **Fast**  
Deposits: ☒ None ☐ Mud ☐ Sludge ☐ Debris ☐ Grease  
Silt Depth: (in.) Deposits Extent:  
Infiltration: **None** Pipe Seal Cond: **Sound**

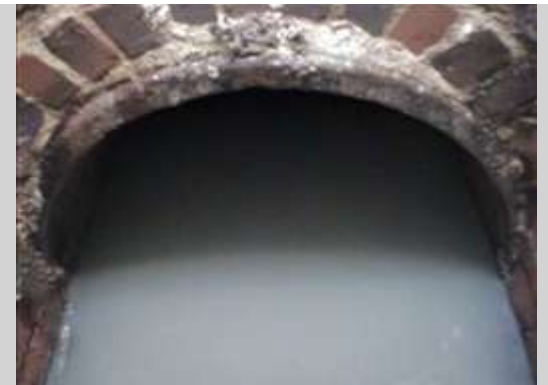
6 O'Clock Inflow

30 in. Circular Gravity Sewer  
Pipe In @ 6 O'Clock

Pipe Height: **30** (in.) Rod and Bar (Angled)  
Pipe Material: **Concrete** ☐ Pipe Lined  
Invert Depth: **16.30** (ft.) Flow Characteristics: **Fast**  
Deposits: ☒ None ☐ Mud ☐ Sludge ☐ Debris ☐ Grease  
Silt Depth: (in.) Deposits Extent:  
Infiltration: **None** Pipe Seal Cond: **Sound**
